Aldarra Lots M & N Preliminary Plat

Level One Downstream Analysis and Preliminary Drainage Control Plan

Prepared for:
Taconite, LLC

October 2018
Job Number: 16155

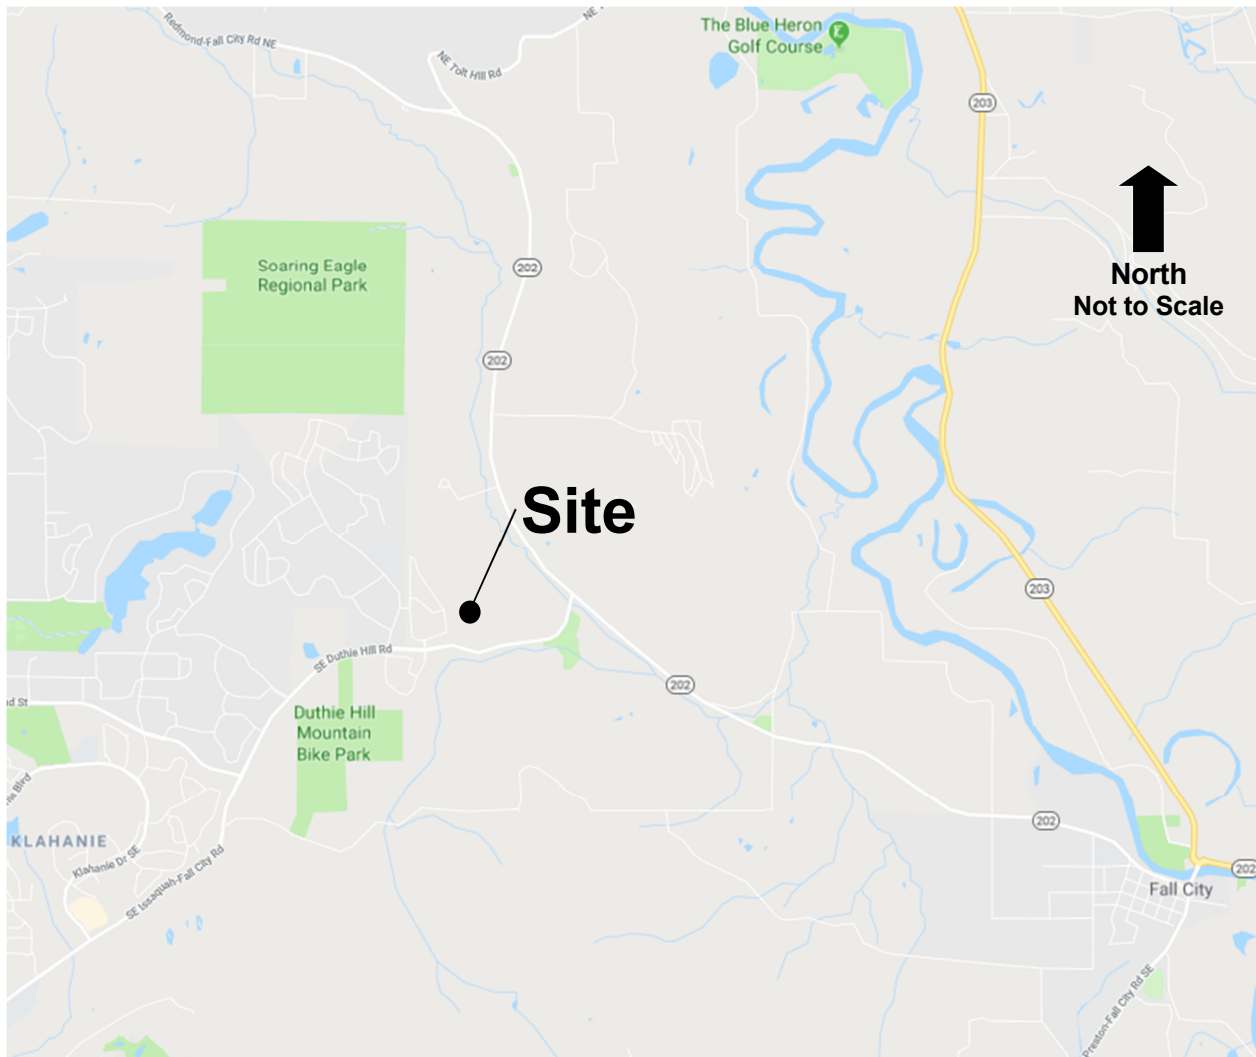
FIGURE 1

Vicinity Map

28212 SE DUTHIE HILL ROAD

The Aldarra Lots M & N Preliminary Plat project site (the “Project”) location is shown on Figure 1 (Vicinity Map). The site is located in Unincorporated King County in the NW Quarter of Section 7, Township 24 N, Range 7 E, and the SW Quarter of Section 6, Township 24 N, Range 7 E, W.M. at 28212 SE Duthie Hill Road. The 45.08 acre site is zoned R-1-P with R-1-P zoned property located adjacent to the project on all sides (R1 within Sammamish to the West). This project site is located in the Patterson Creek basin within the Snoqualmie Watershed.

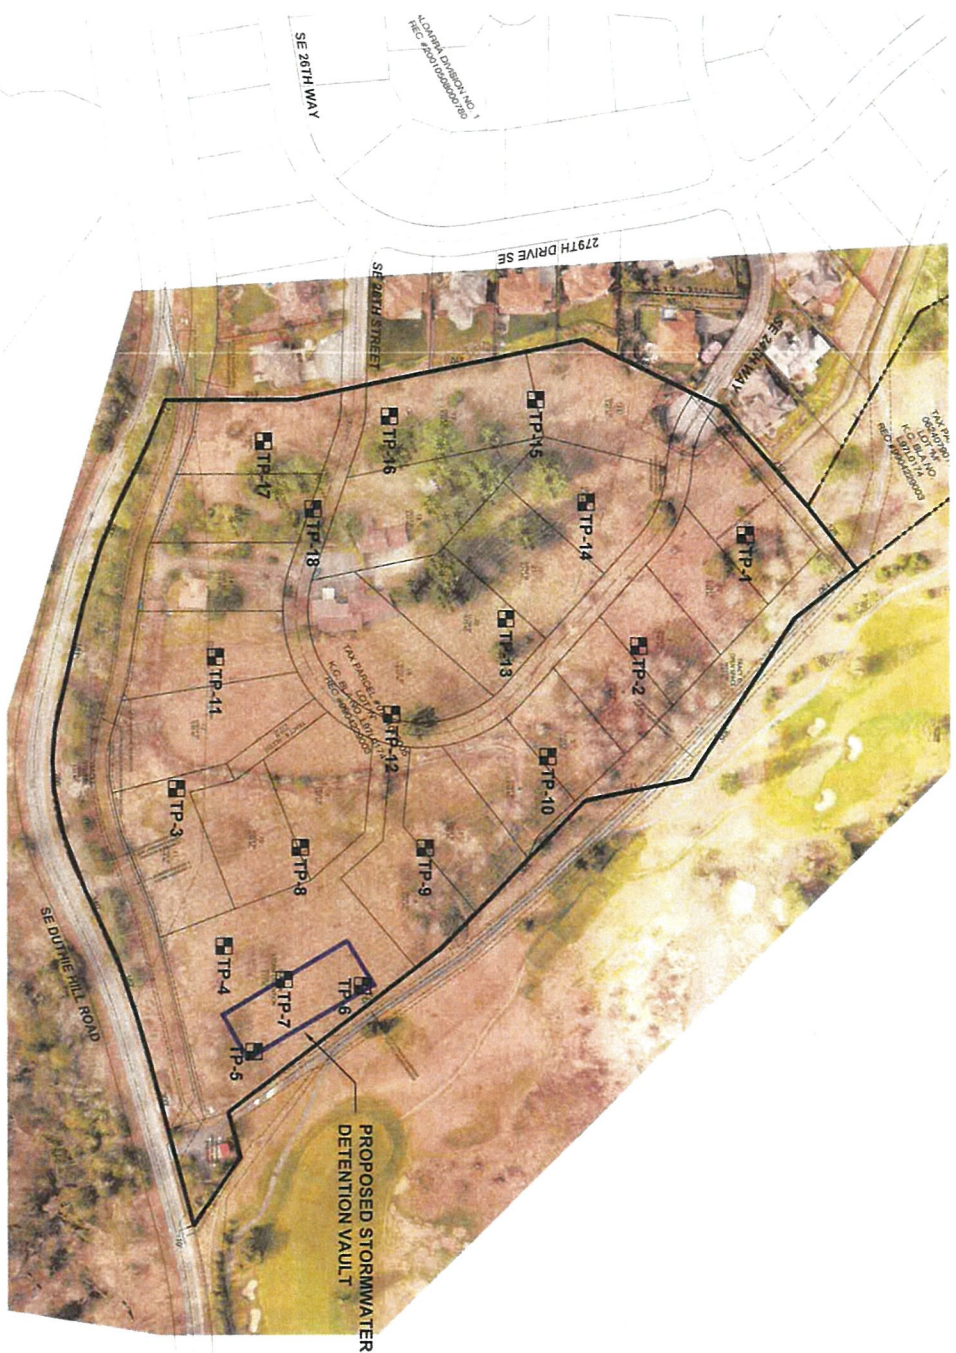
NOTE:
THIS SITE PLAN IS SCHEMATIC. ALL LOCATIONS AND DIMENSIONS ARE APPROXIMATE. IT IS INTENDED FOR REFERENCE ONLY AND SHOULD NOT BE USED FOR DESIGN OR CONSTRUCTION PURPOSES.

REFERENCE:
SITE PLAN BY GOLDSMITH

Detailed descriptions of the subsurface conditions we observed in our site explorations are presented on the Test Pit Logs in Appendix A. The approximate test pit locations are shown on Figure 2.

We explored subsurface conditions at the site in 18 test pits excavated to depths about 9 to 15 feet below ground surface using a track-mounted excavator. The test pit locations are shown on Figure 2. The test pit locations were approximately determined in the field by sighting and pacing relative to existing surface features. The Test Pit Logs are presented as Figures A-2 through A-19.
